**ERDC/CRREL TR-03-21**

## **Use of Military Demolition Explosives in a Remediation Project**

Michael R. Walsh, Charles M. Collins, Michael T. Meeks,  
Alvin O. Lee, and Eric G. Wahlgren

October 2003

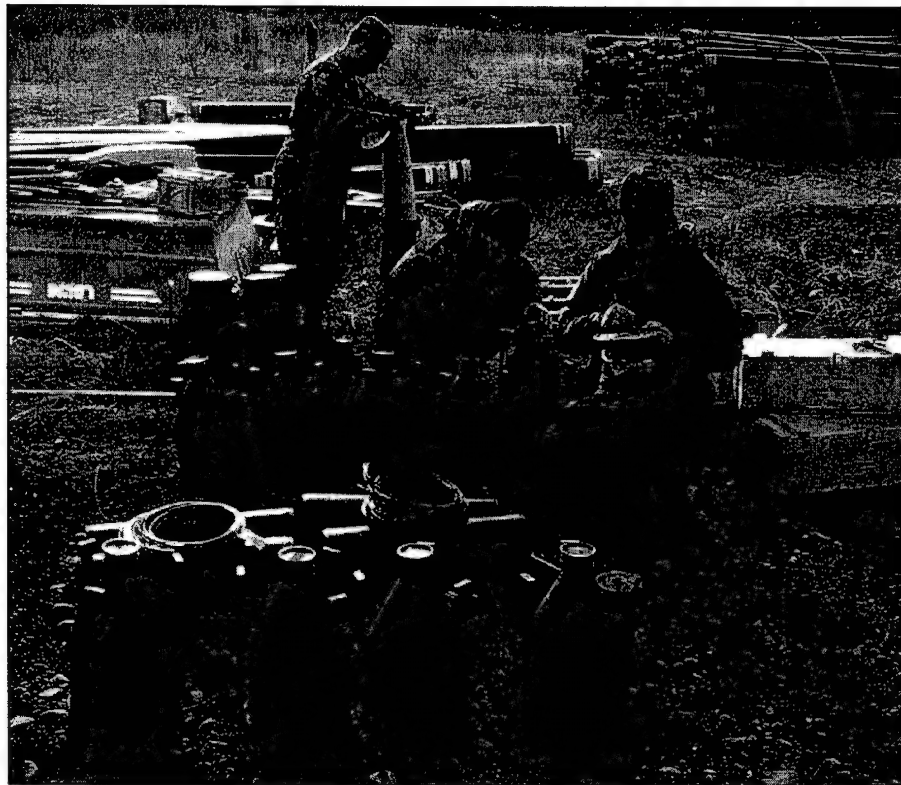
**Figure 4. Preparation of shaped (foreground) and cratering charges.**

The Bread Truck ditch was excavated in two stages (Fig. 4). The first stage used seventeen 18-kg shaped charges to explosively form boreholes into the sediment. The charges were spaced every 5 m along the centerline of the planned ditch. Type 1 M45 line main detonation cord (29.5 g/m, 6.4 lb/1000 ft) connected all seventeen shaped charges together. A dual detonating firing system consisting of two fuse igniters, two lengths of time fuse cut to 7-minute lengths, and two blasting caps was used. When detonated, the shaped charge produces a plasma jet that will punch a 30-cm-diameter hole straight down into the ground. The total

amount of explosives detonated in this first explosion was approximately 320 kg (700 lb). Following a sweep of the area for UXOs, the second stage of the explosive excavation was set up. An 18-kg cratering charge was placed in each of the boreholes created by the shaped charges. The charges were wired together in a similar manner to the shaped charges. One or more sandbags were placed in most of the boreholes on top of the cratering charges. The number and way the sandbags were placed varied from hole to hole, depending on the soldier who did the placement. Since all the boreholes were filled with water from the pond, it was difficult to determine how effective the sandbags were in tamping the underlying charge.

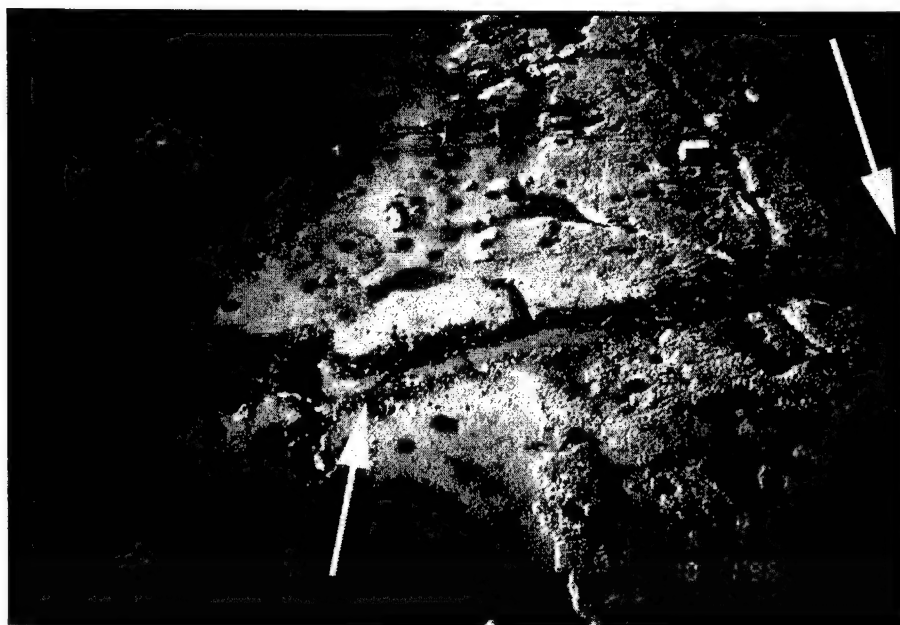
**Figure 5.** Bread Truck ditch, October 1996. Arrows point to the ends of the blasted ditch. Headwall erosion is evident to the left of the left arrow.

The explosion of the cratering charges produced a series of craters forming a nearly continuous ditch 90 m long. Craters were up to 2 m deep and varied from 3.3 to over 6 m in diameter. The mean crater diameter was 4.92 m. The smallest-diameter craters were within the slightly higher vegetated mudflat area near the northern end of the ditch and in the pond sediments at the southern end. The ground at the northern end was more deeply frozen, and the explosive charges

may not have been as efficient in removing material. It is unclear why the craters at the southern end were smaller than predicted. Differences in crater diameter were likely due to differences in the effectiveness of tamping. Between one and three sand bags were placed in each borehole above the cratering charge, and almost all holes were filled with meltwater. The smaller-than-expected size of several of the craters caused some craters not to overlap. This created several blockages that prevented any initial flow through the ditch. Following the spring thawing of the pond ice and the surrounding seasonally frozen ground, a series of flooding high tides in late May eroded the blockages and initiated draining of the pond on 19 May 1996. Accelerated headwall erosion was evident by October of that year (Fig. 5).

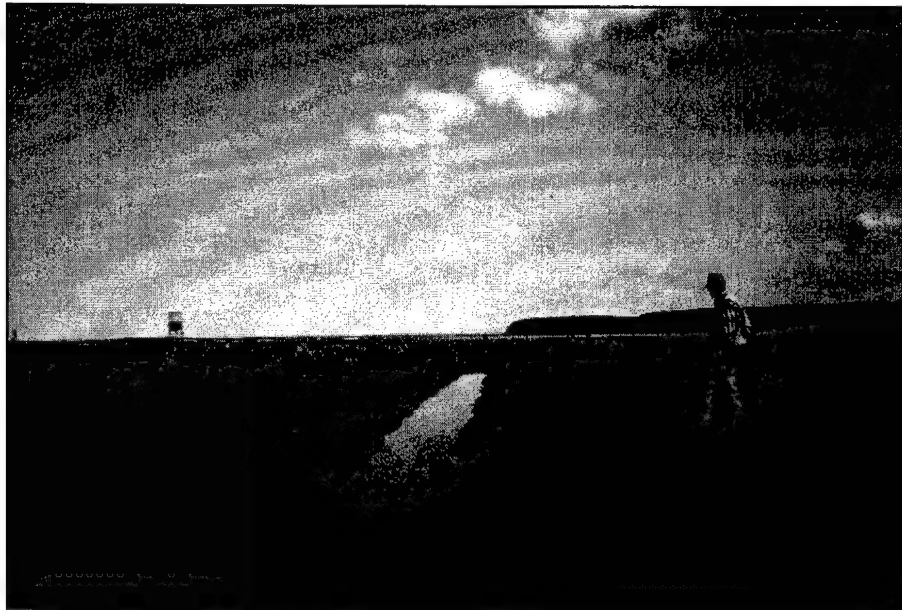
**Figure 6. Drainage ditch at Pond 293 (cratering charges).**

The detonation of all forty cratering charges produced a large explosion that threw material several hundred meters into the air. The explosion formed a nearly straight 120-m-long ditch, 2 m deep and 4.7–5 m wide, leading from the pond to the gully (Fig. 6). The problems encountered the previous year with the Pond 109 ditch with various sizes of craters and with some craters not overlapping were completely avoided. The closer spacing of cratering charges and the tamping of the boreholes containing the cratering charges with sandbags produced a more constrained explosion and a more consistent lateral excavation of ground material. Immediately following the blast, water started flowing into the newly excavated ditch from Pond 293. The first crater at the north end of the ditch was a

meter and a half deeper than the pond where it was located, resulting in a cascade of water down into the crater. Water continued to flow into and fill the ditch for about twenty minutes. After the ditch filled with water, it began to erode the berm thrown up around the last crater at the end of the ditch and flow out of the south end of ditch into the ice-filled gully and hence into the river. Water continued to flow out of Pond 293 and the surrounding sedge marsh for several weeks until the area drained.

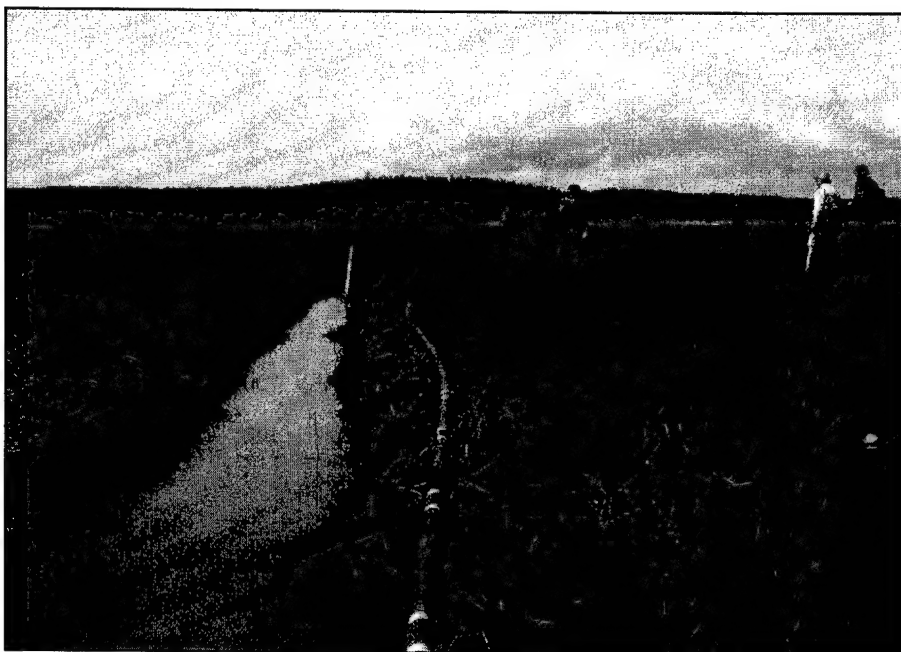
**Figure 7. Laying out Bangalore torpedoes.**

cratering charges to lessen the impact. Bangalore torpedoes are cylindrical demolition charges 1.52 m in length and 54 mm in diameter. The primary explosive component is Comp B4 (4.76 kg), with a 0.46-kg Comp A3 booster (U.S. Army 1998). The M1A2 Bangalore kit consists of 10 sections of torpedoes that can be assembled end-to-end using supplied sleeves to create a line charge. Any number of Bangalores can be assembled in this manner. The line charges used for ditching Pond 285 were initiated using M45 Type 1 detonation cord, a time fuse, and blasting caps placed in the detonator well of the Bangalore. Tests conducted in terrain in the Flats similar to that to be encountered between Pond 285 and the south channel of the Eagle River indicated that Bangalores placed on or cut slightly into the unfrozen surface of the sedge meadow characteristic of this area will create a ditch approximately 1 m wide by 70 cm deep.

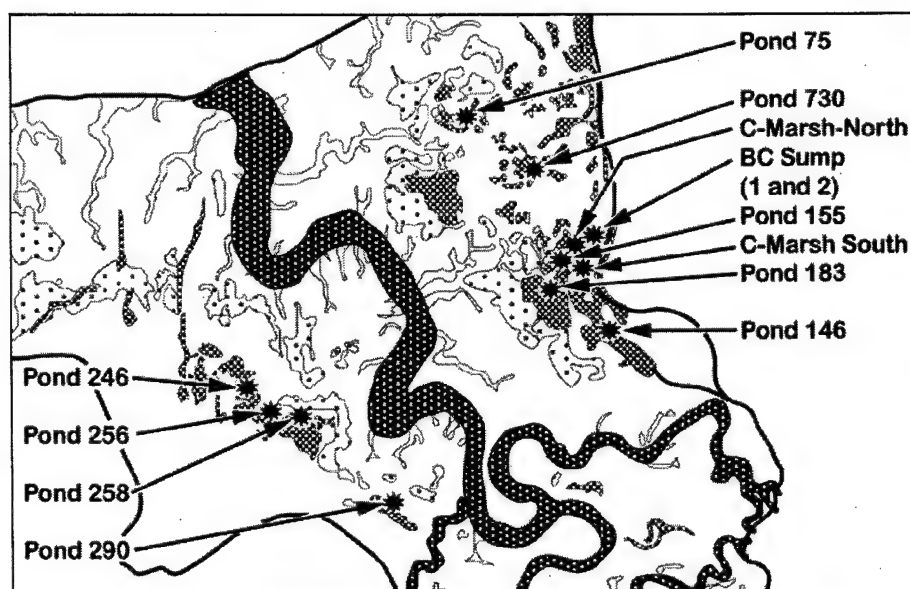
Figure 9. Location of sumps for pond-draining missions.

At Eagle River Flats, demolitions support for the pond-pumping remediation project during a given season typically involves multiple missions. In the spring, prior to complete thawing of the soil, or in the fall, after the equipment has been pulled, sumps are blown for the pumps and the rims of the sumps breached using Bangalore torpedoes. About a month after the pumps are deployed, when the ponds have drained to the extent possible, ditching lanes are marked for drainage from low points to the sump. The engineers then return to blast the drainage ditches to the sumps. At this time, if there is any other demolition that needs to be done, it is scheduled on top of this mission or for a later date. In all blasting missions, a helicopter must be on site for casualty evacuation in case of an accident. Some means of fire suppression is also necessary in case the demolitions spark a brush fire. Figure 9 shows the locations of sumps created for the project between 1997 and 2002.

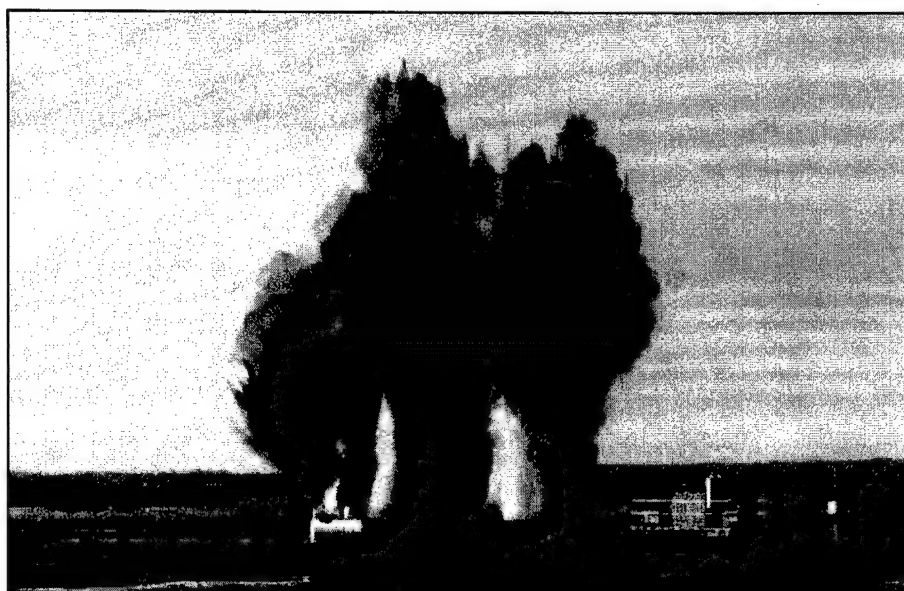
**Figure 10. Blasting a sump drainage ditch with Bangalore torpedoes and det cord.**

Ditching from isolated low points within a pond or adjacent ponded areas to the sump requires the formation of small (20- × 30-cm) ditches. Both Bangalores and detonation (det) cord (M456) have been used successfully to form these ditches: Bangalores where high points or hardpan needs to be breached and detonation cord elsewhere (Fig. 10). The detonation cord is preassembled into five-strand twisted bundles about 30 m long wrapped with ty-wraps every 3 m prior to field placement (Fig. 11). When using det cord, forcing it into the mud or pre-cutting slots into vegetated areas and inserting the det cord into the slots greatly

enhances its effectiveness. Recently, we have found that doubling up the detonation cord (10-strand) and inserting it in precut slots in the areas where previously only Bangalores would work, such as heavily vegetated areas will form a sufficient drainage ditch. This allows ditching through difficult materials to be conducted closer to sensitive equipment without the concussion caused by the much larger Bangalores. Ditching to sumps is now done almost exclusively with det cord.
